1. Report No. USCG 16732/93261		2. Government Accession No. AD-A207 642		3. Recipient's Catalog No.	
4. Title and Subtitle Marine Casualty Report Uninspected Self-Elevating Mobile Drilling Unit RANGER I: collapse and sinking in the Gulf of Mexico on 10 May 1979 with loss of life				5. Report Date 13 May 1981

COLLAPSE AND SINKING OF MOBILE OFFSHORE DRILLING  
UNIT RANGER I IN THE GULF OF MEXICO ON 10 MAY 1979  
WITH LOSS OF LIFE

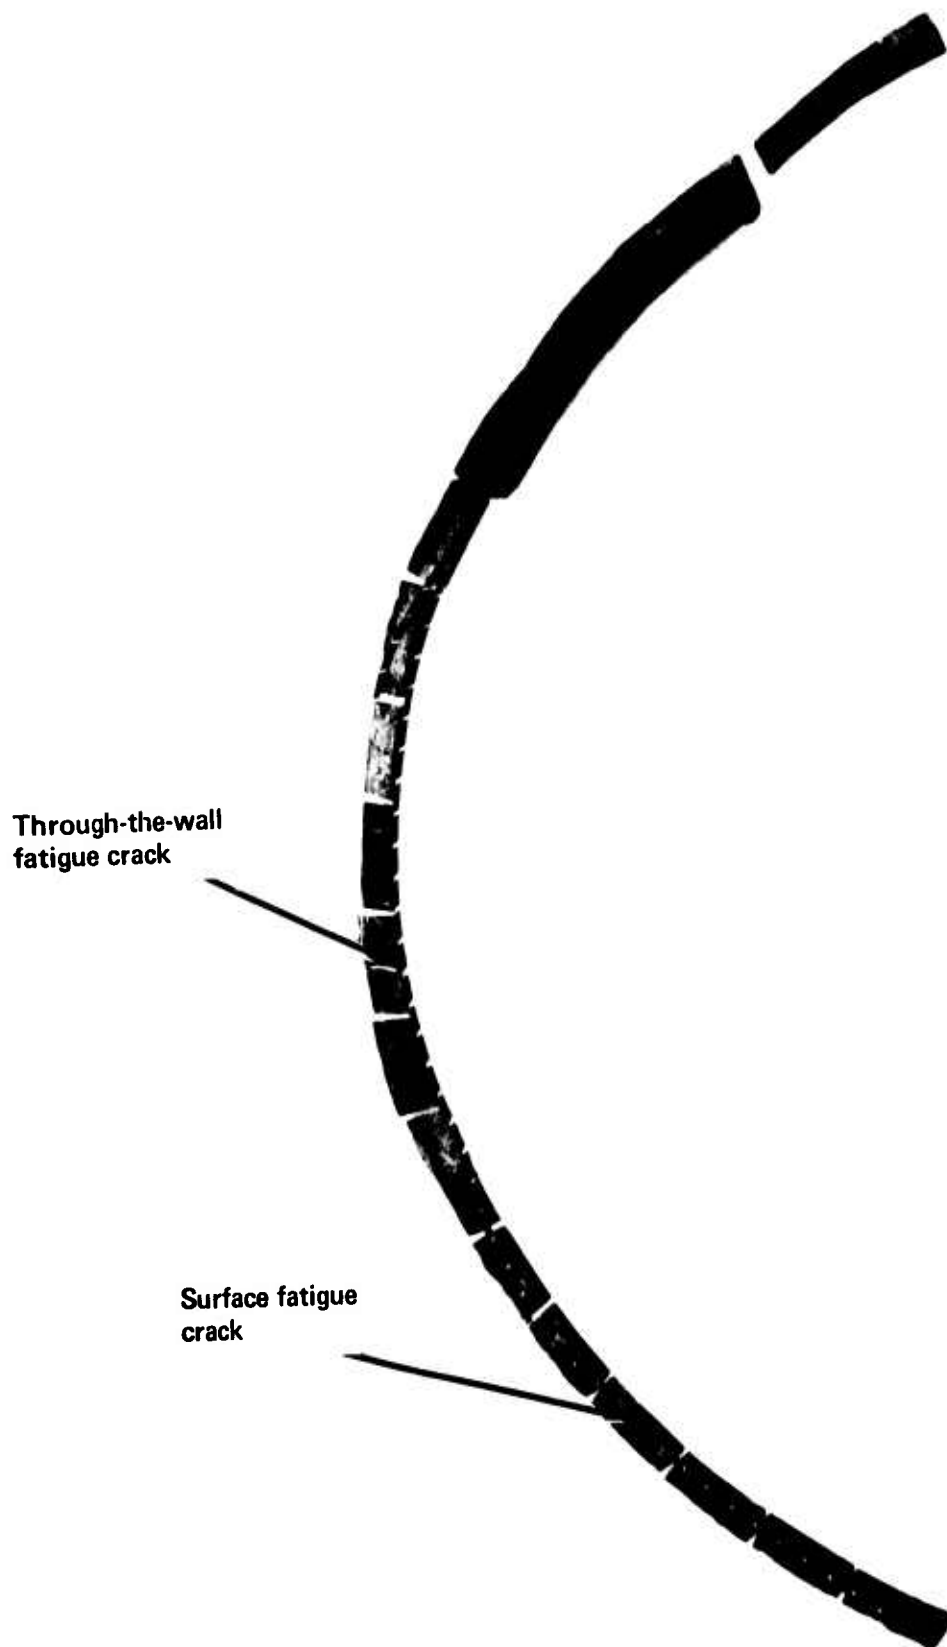
FIGURE 7 – CATASTROPHIC FRACTURE SURFACE OF PORT SIDE OF STERN LEG.

The stern support leg was fractured near its connection to the mat. This catastrophic fracture began on the port side of the leg at the upper toe of a continuous fillet weld that attached a stiffener ring to the stern leg. The fracture extended completely around the leg and was inclined upward toward the starboard side. A stub of the stern leg remained attached to the mat. It varied in height from 4 inches on the port to 15 inches on the starboard side. The fractured surfaces showed matted chevrons that pointed to the port side of the leg. The mat deck plating was pushed in on the port side and the barnacles in way of this deformation were scraped off. The lower end of the fractured leg mated with the deformation in deck plating when it was inclined from the vertical about 9 to 11 degrees to starboard. The upper end of this leg was sheared at the 90 foot level. The starboard leg was bent at the 38 foot level and it remained attached to the mat. The upper end was sheared at the 90 foot level. The port leg was broken off at the 68 foot level. (See figure 6)

SEM studies were inconclusive in identifying fatigue on the catastrophic fracture surface because of heavy oxide and surface deposits. However, TEM studies showed a through-the-wall fatigue crack of about 23 inches centered on the port side of the stern leg and a surface crack of about 14 inches centered on the after port side of the stern leg. The two fatigue cracks joined on the port side. The surface crack extended 50 to 70 percent through-the-wall of the stern leg. Also, the TEM studies were used to count fatigue striations on the surface of the catastrophic

fracture. Although fine fatigue striations were removed by corrosive action of the sea water, the studies showed that the 23 inch fatigue crack was propagating for at least 400 days. TEM studies of the starboard side of the catastrophic fracture showed a quasi-cleavage mode of failure. (See figure 7)
